UNITED STATES ENVIRONMENTAL PROTECTION AGENCY

RE: Request for Information (RFI) Pursuant to Section 308 of the Clean Water Act
Compliance Evaluation Inspection Report for CEI conducted on May 7, 2014
Willow Breeze Farm, LLC Concentrated Animal Feeding Operation (NYA000297)
Docket No. CWA-IR-14-021

CAFO COMPLIANCE INSPECTION REPORT

| Site Information: | Willow Breeze Farm, LLC 5799 Route 41 Homer, New York 13077 NPDES/ICIS No. NYA000297 |

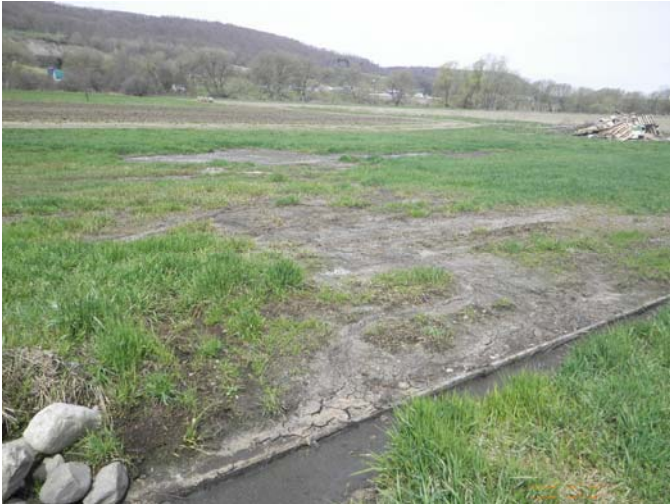
At the time of the inspection, EPA inspector McEathron observed dead vegetation and pooling high flow silage leachate in the VTA extending north through the VTA.

RIMG0003.JPG – Dead vegetation in the VTA on the west side of the level lip spreader

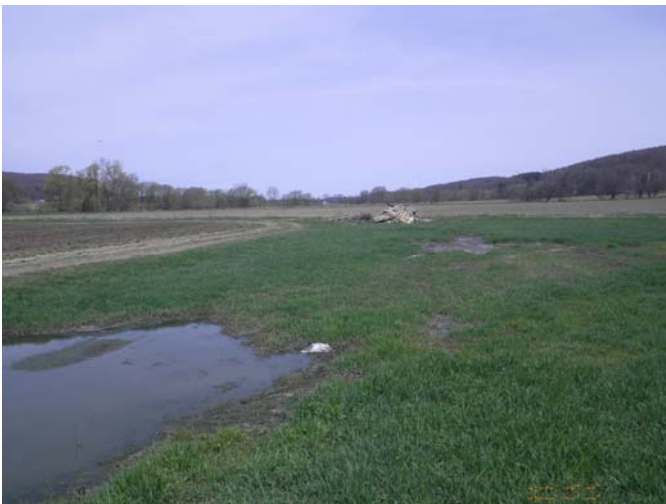
1. Section X.G of the CAFO General Permit requires the permittee to at all times properly operate and maintain all facilities and systems of treatment and control (and related appurtenances) which are installed or used by the permittee to achieve compliance with the permit. At the time of the inspection, inadequate operation and maintenance was observed at the following locations:
 - a. Dead vegetation in the Vegetated Treatment Area (VTA) on the west side of the level lip spreader (see photograph RIMG0003.JPG); and
 - b. Pooling high flow silage leachate in the VTA extending north through the VTA (see photograph RIMG0004.JPG).

RIMG0004.JPG – Pooling high flow silage leachate in the VTA extending north

1. No later than thirty (30) calendar days of receipt of this RFI, submit documentation with accompanying photographs of the measures taken to address the Potential Violation and each of the Areas of Concern specified in the enclosed Inspection Report, including temporary measures implemented to properly Operate and Maintain the existing silage leachate collection and treatment system and an implementation schedule for the new Vegetated Treatment Area;
2. No later than thirty (30) calendar days of receipt of this RFI, submit revised Facility Maps depicting all drainage pipes, clean water diversions and material storage locations; and
3. No later than seven (7) calendar days after completion of the VTA, submit to EPA certification that the CNMP has been fully implemented by the proposed deadline, including completion of the silage leachate collection system.

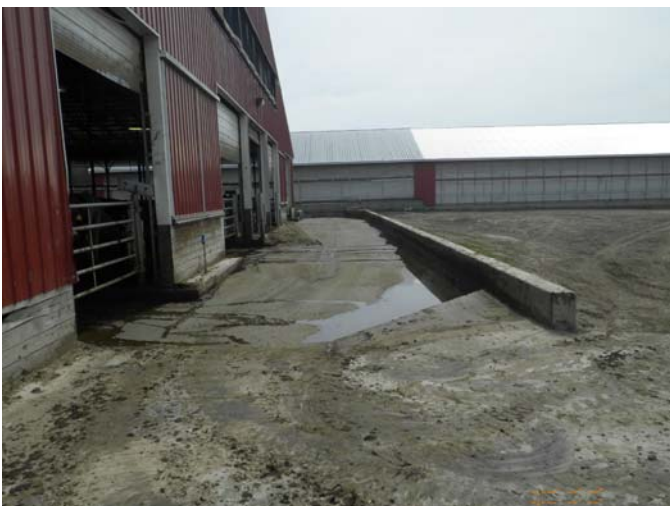
RIMG0013.JPG – Manure along the southwest side of the Freestall Barn 1

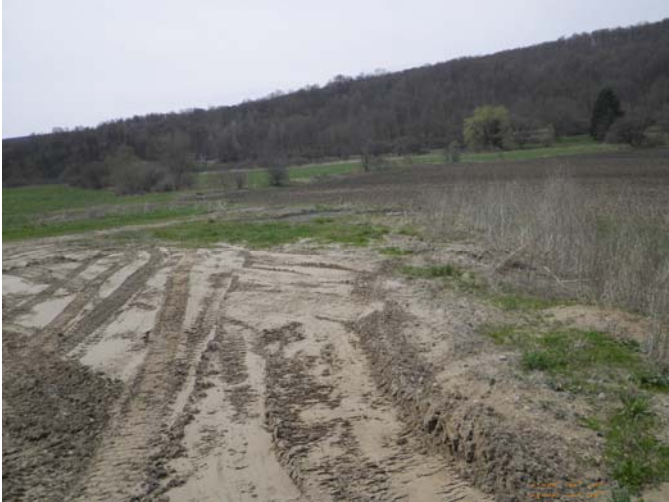
EPA inspector McEathron observed that stormwater can come into contact with manure and feed at the Main Facility as described in paragraph 3 of the Areas of Concern section of this report. Stormwater runoff from these locations at the Main Facility flows west to adjacent fields via drainage ditches and surface runoff.

RIMG0014.JPG – Adjacent field west of the Main Facility where stormwater runoff is directed

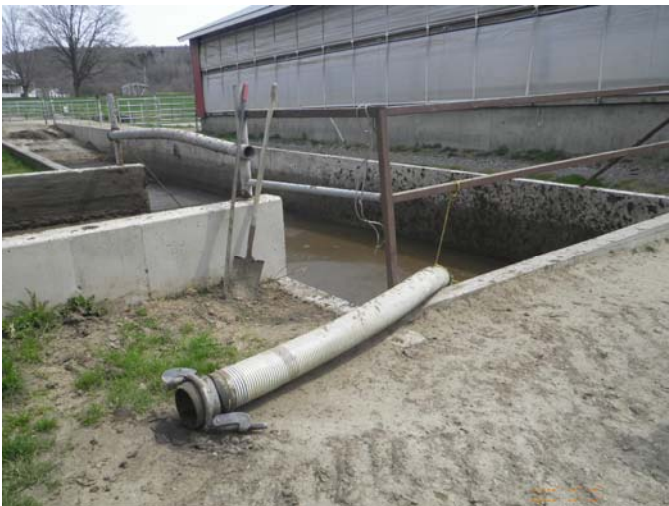
RIMG0015.JPG – Manure exposed to stormwater adjacent to the New Barn Manure Pit

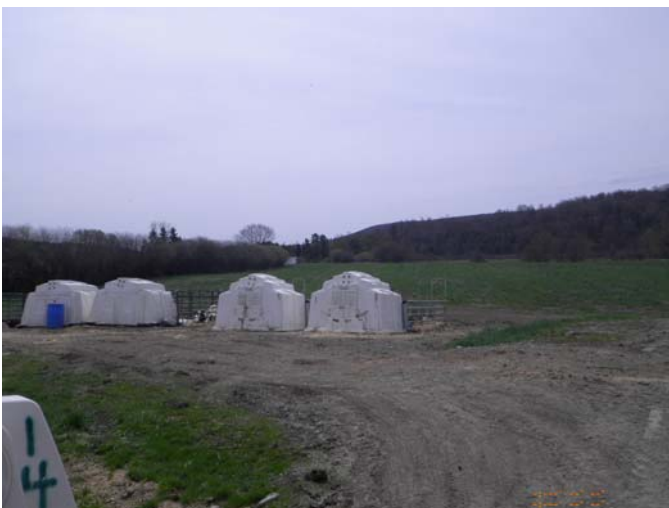
RIMG0015.JPG – Manure and feed exposed to stormwater at the calf hutches

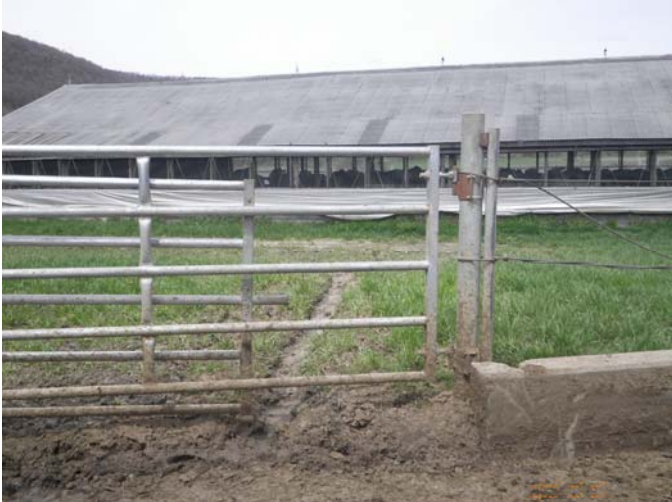
- e. Manure exposed to stormwater at an uncurbed portion of the cattle walkway just north of the Freestall Barn 1 where stormwater can run on and through manure on the walkway to a vegetated area where erosion was observed at the Main Facility (see photographs RIMG0019.JPG – RIMG0021.JPG).

RIMG0019.JPG – Erosion channel observed in vegetation downhill from walkway

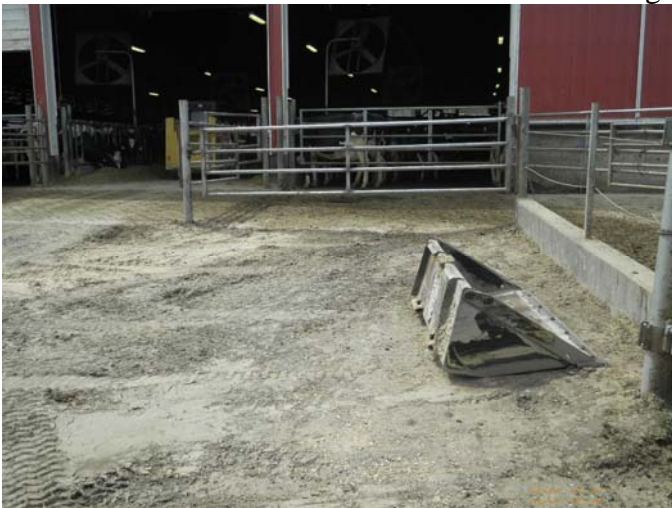
RIMG0020.JPG–Manure and feed exposed to stormwater at the northeast end of Freestall Barn 1

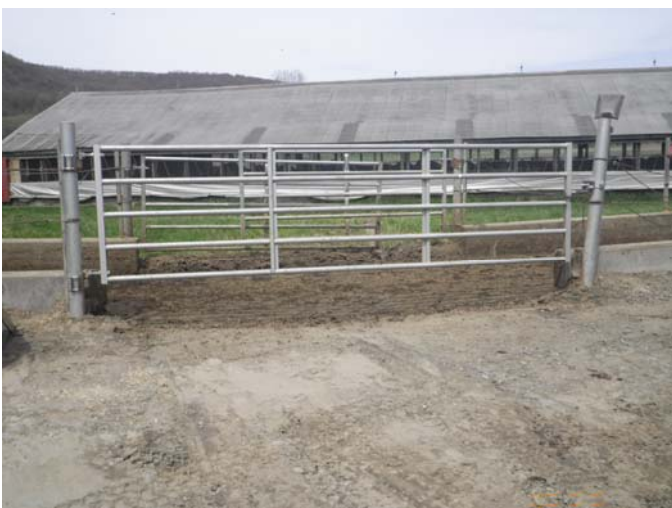
RIMG0021.JPG – Manure exposed to stormwater at an uncurbed portion of the cattle walkway just north of the Freestall Barn 1

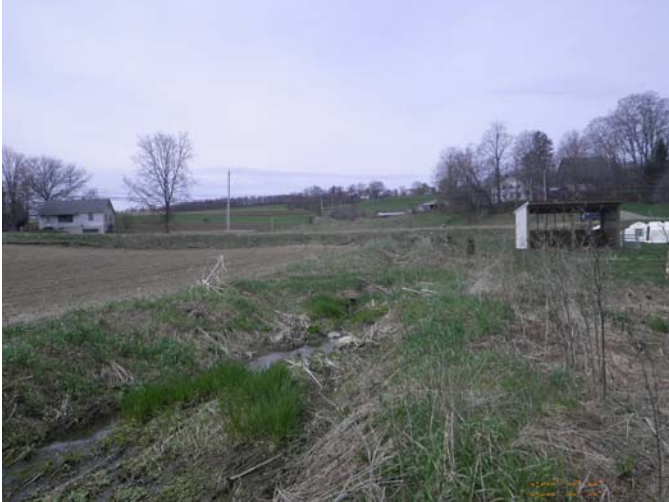
4. At the time of the inspection, EPA observed an unpaved driveway at the Heifer Facility/Chad's Farm that extends from the bedded pack manure storage structure approximately 100 feet south over the Factory Brook to an adjacent field (see photograph RIMG0024.JPG). The permittee should ensure that the banks of the Factory Brook remain vegetated and that the manure storage continue to be properly operated and maintained to prevent pollutants from travelling from the storage to the Factory Brook.

RIMG0024.JPG – Vegetated banks of the Factory Brook, south of the Heifer Facility
